HYDROGEN ASSISTED CRACKING OF UHSS
FOR MILITARY AEROSPACE APPLICATIONS

DISSERTATION

Benjamin R. Steffens, Maj, USAF
aus Torrejon Air Force Base, Spanien

Hamburg, 2018

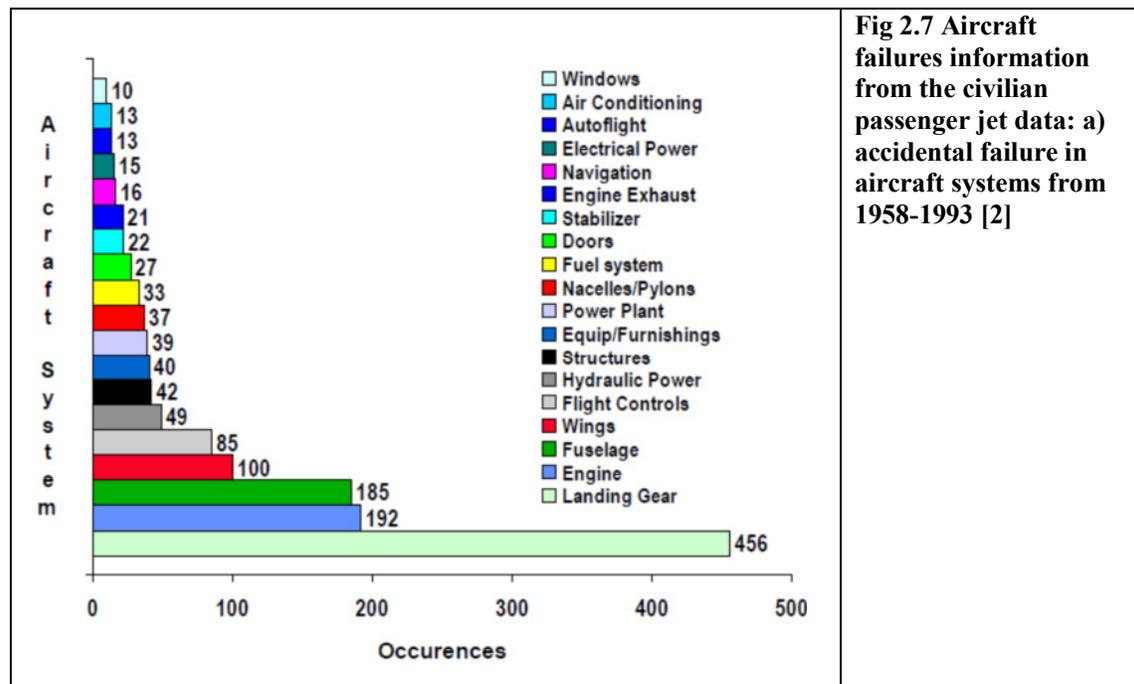
Fig 2.7 Aircraft failures information from the civilian passenger jet data: a) accidental failure in aircraft systems from 1958-1993 [2]

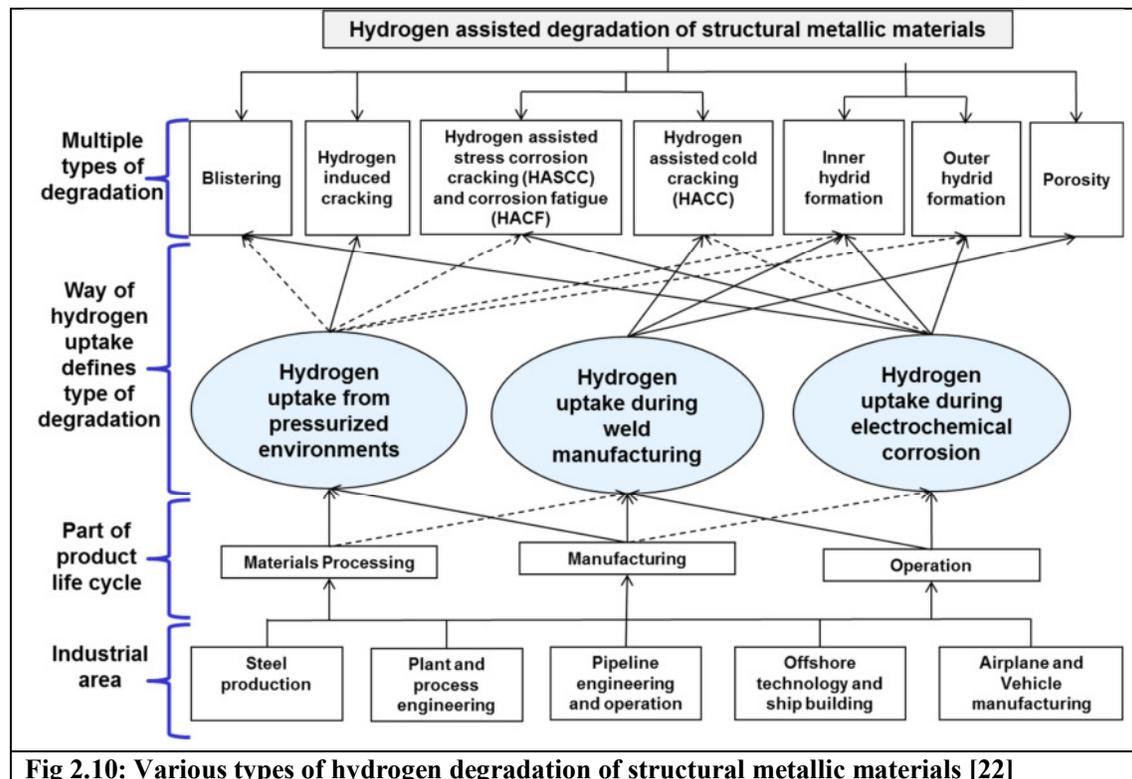
Fig 2.10: Various types of hydrogen degradation of structural metallic materials [22]

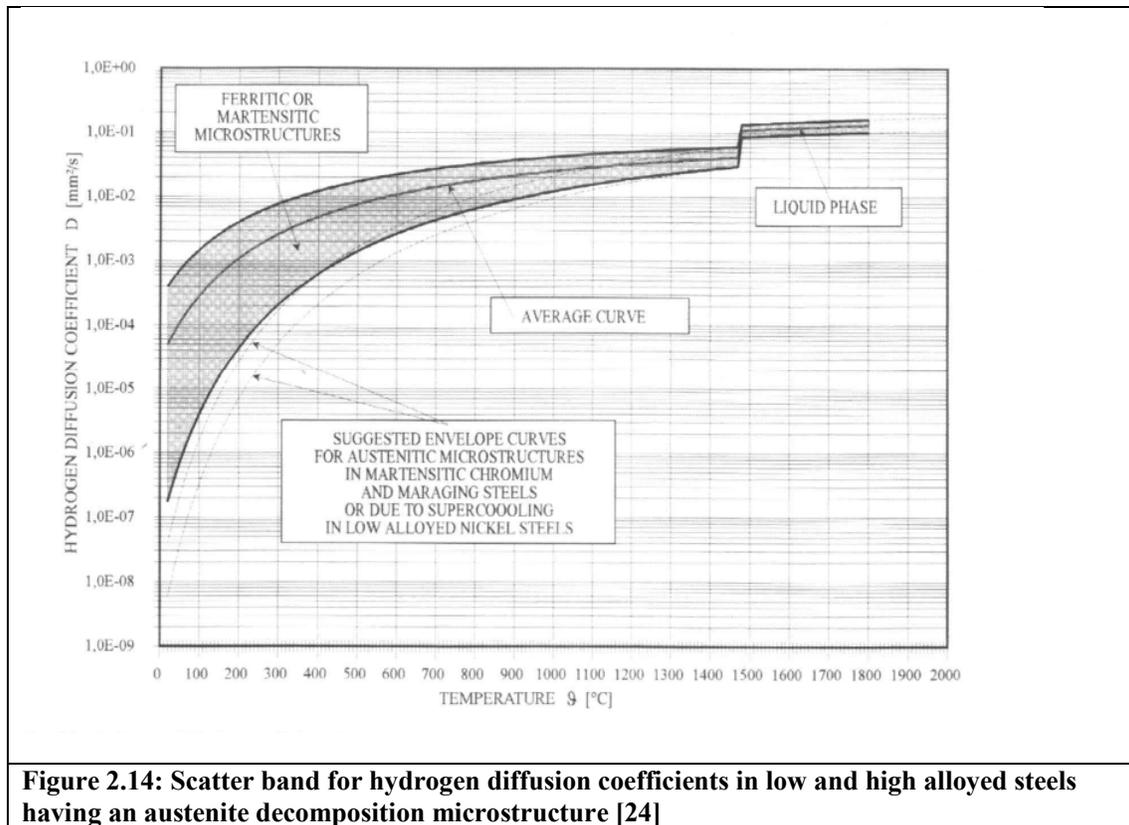
Figure 2.14: Scatter band for hydrogen diffusion coefficients in low and high alloyed steels having an austenite decomposition microstructure [24]

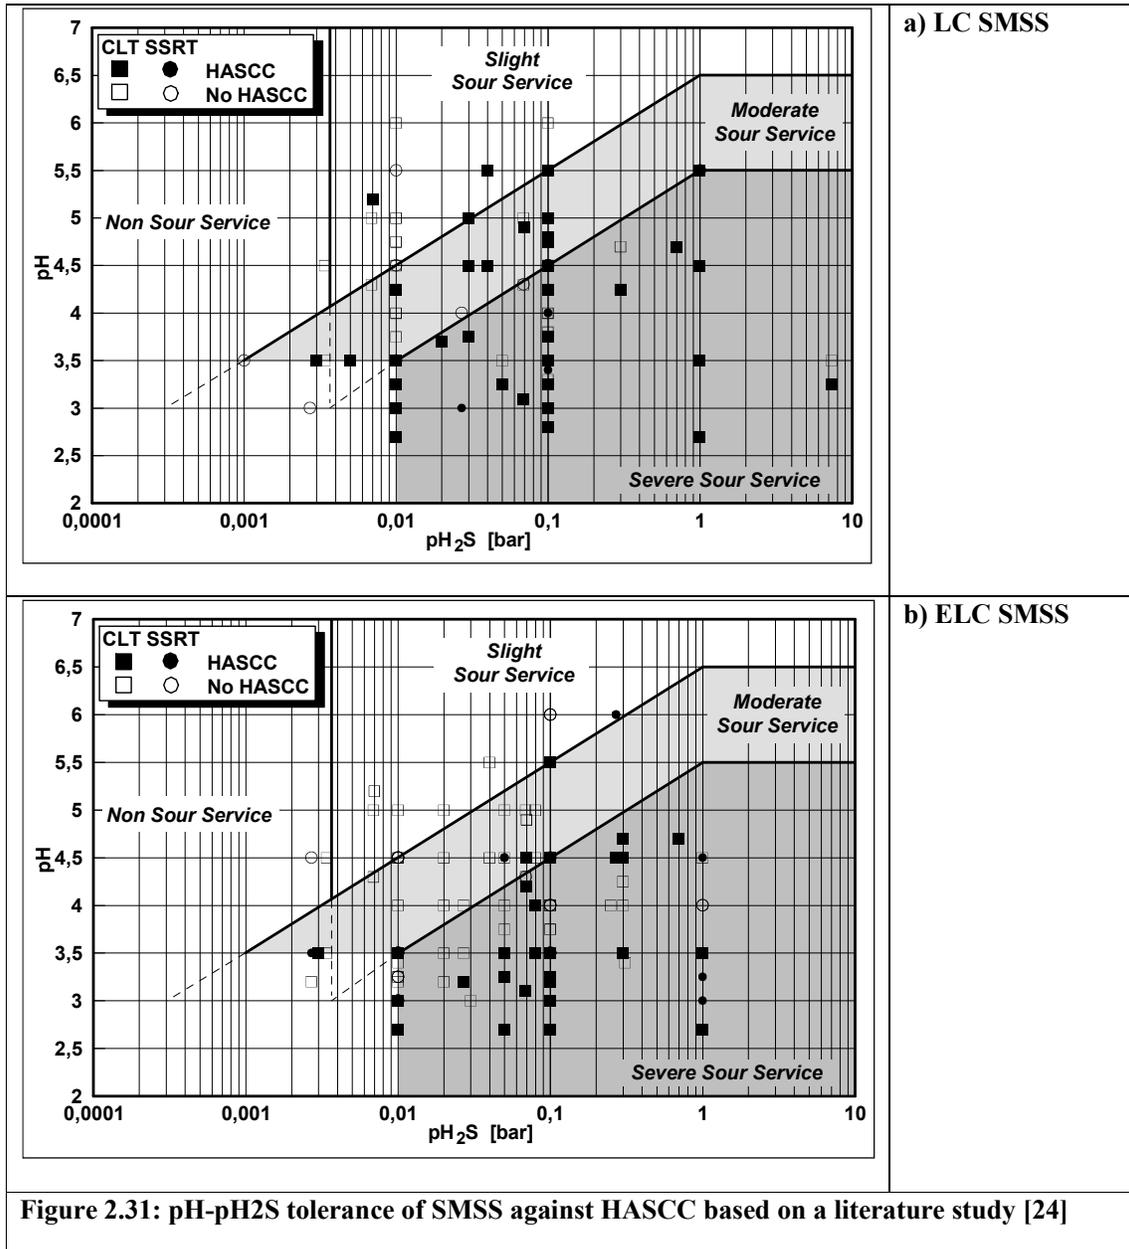
Figure 2.31: pH-pH₂S tolerance of SMSS against HASCC based on a literature study [24]

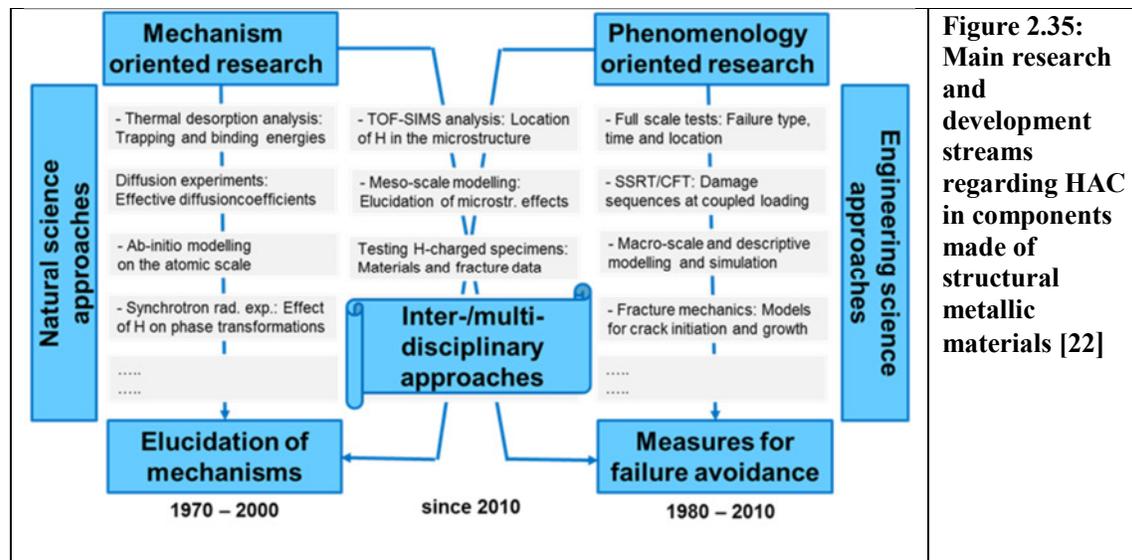
Figure 2.35: Main research and development streams regarding HAC in components made of structural metallic materials [22]

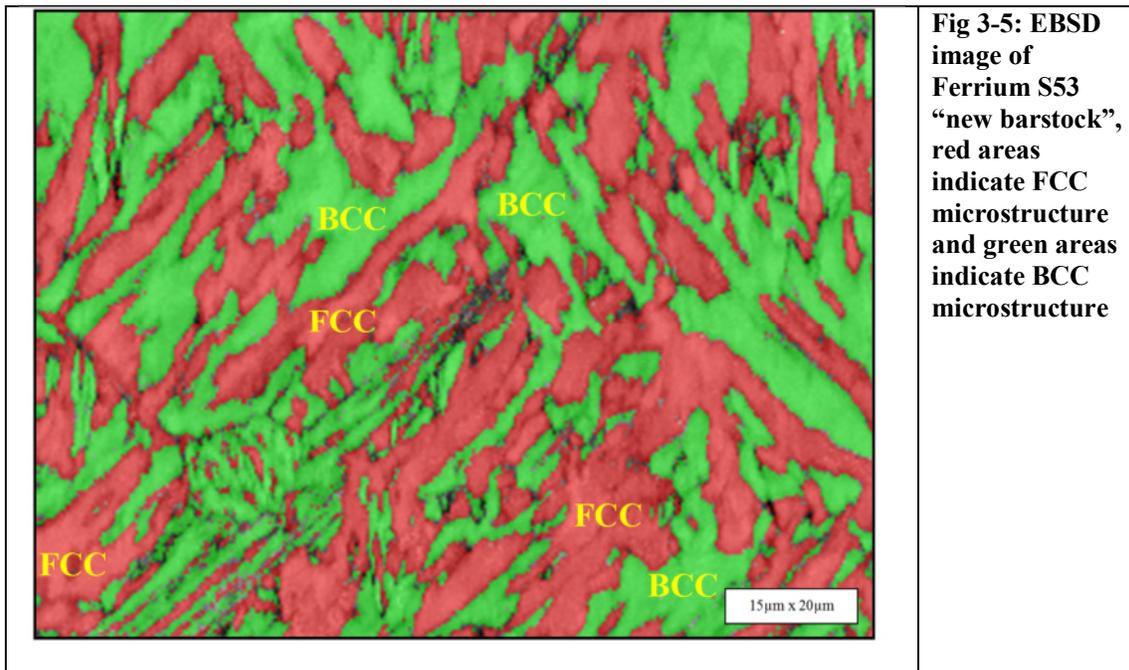
Fig 3-5: EBSD image of Ferrium S53 “new barstock”, red areas indicate FCC microstructure and green areas indicate BCC microstructure

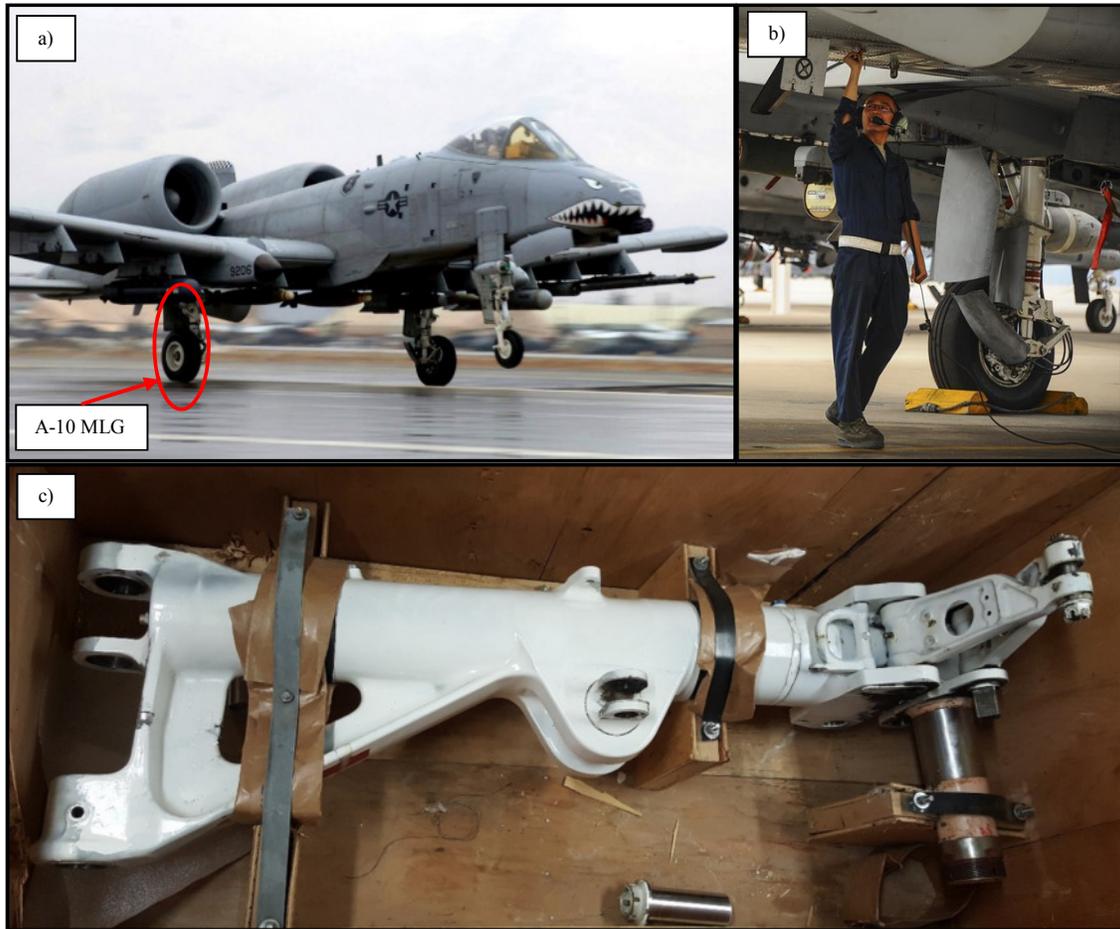
Fig 3-7 Specimen extraction from Fairchild Republic A-10 Thunderbolt II – Close air support combat aircraft of USAF: a) Overview of aircraft, b) MLG close-up, c) Actual MLG as received

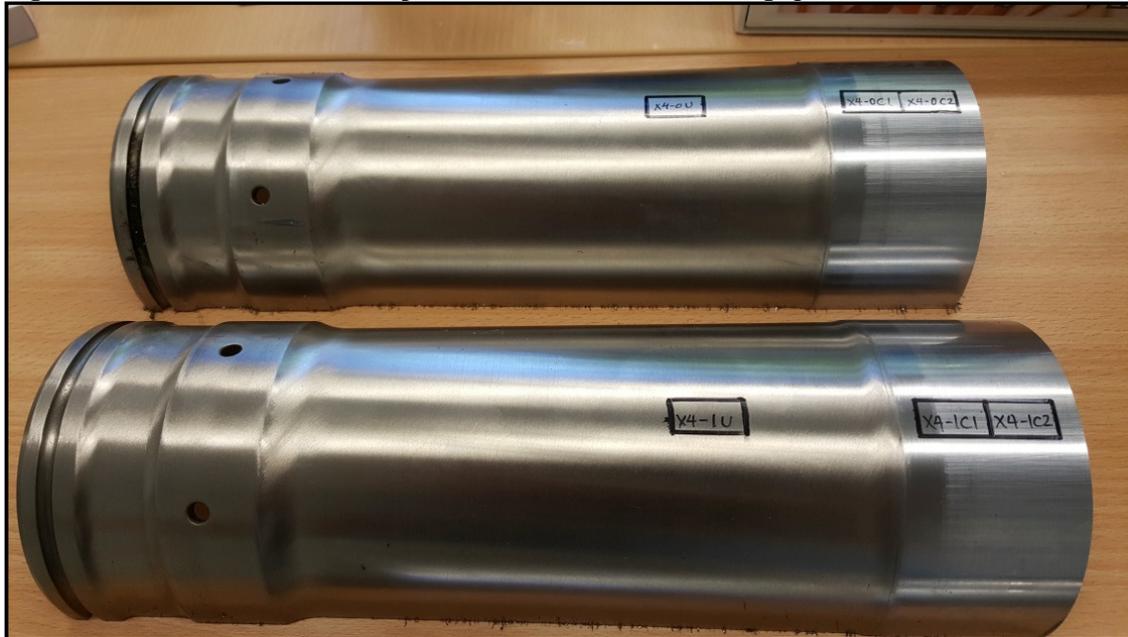
Fig 3-9: A-10 aircraft S53 MLG piston stanchion tube indicating specimen extraction sites

In Fig 3-8 and Fig 3-9, specimens were taken to establish whether the chrome plating process on the piston stanchion tube had introduced any hydrogen at the plating-substrate interface. These (10mm x 20mm x full wall thickness) specimens were extracted using a water jet operation to keep the heat input to a minimum. They were then analyzed using the Carrier Gas Hot Extraction method which is explained in section 3.3.

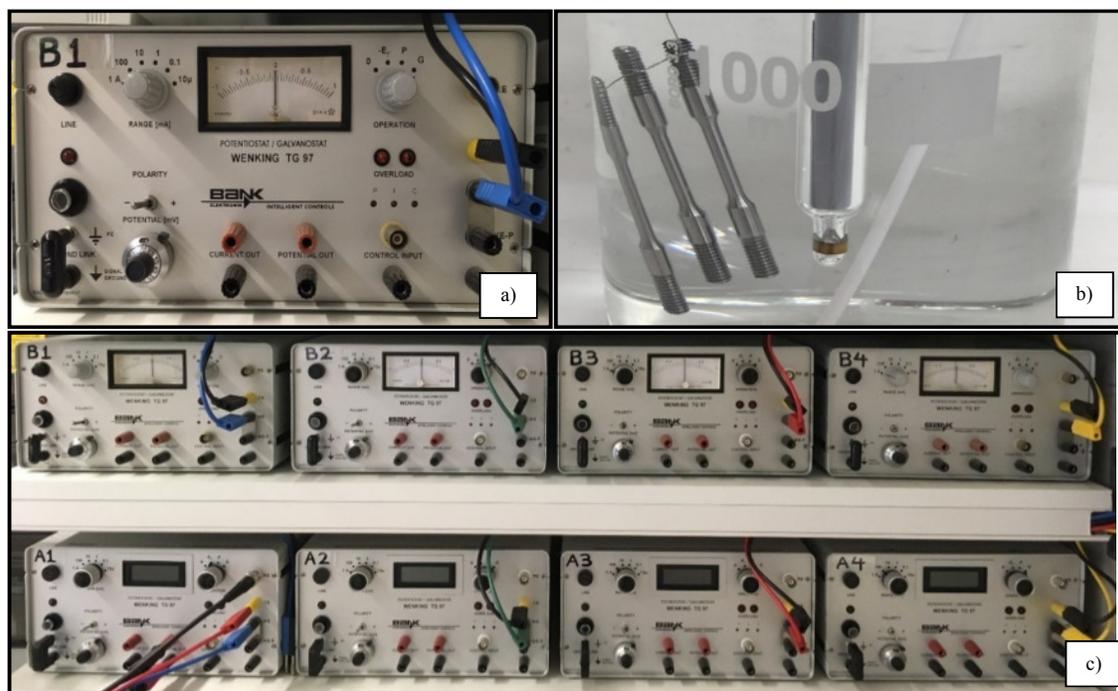
Fig 3-15: a) Bank Elektronik TG97 Potentiostat/Galvanostat, b) charging tensile specimens in the same manner as the concentration evaluator specimens, c) array of TG97's in corrosion lab

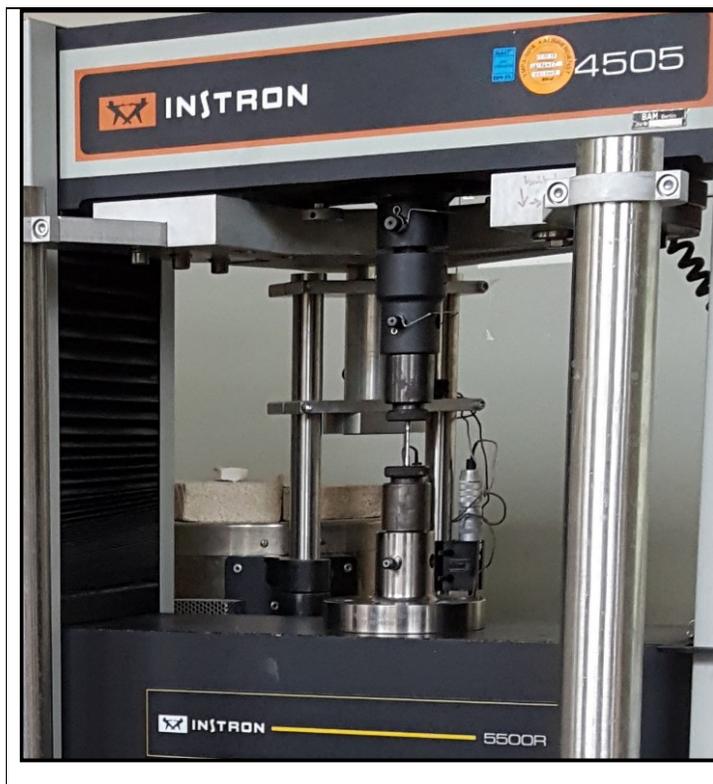
Fig 3-16: Instron 4505 50kN load frame with gimbal on upper head to ensure only axial loading – tensile specimen mounted and undergoing severe necking prior to fracture

Mechanical testing of uncharged and charged tensile specimens, as shown in Fig. 3-16, was carried out on an Instron 4505 50 kN load frame. An extensometer was only fitted to the uncharged specimens due to the brittle failure of the charged specimens. Instead, the true strain was calculated in accordance to previous investigations [107]. The tests were performed at a cross head speed of 1 mm·min⁻¹.

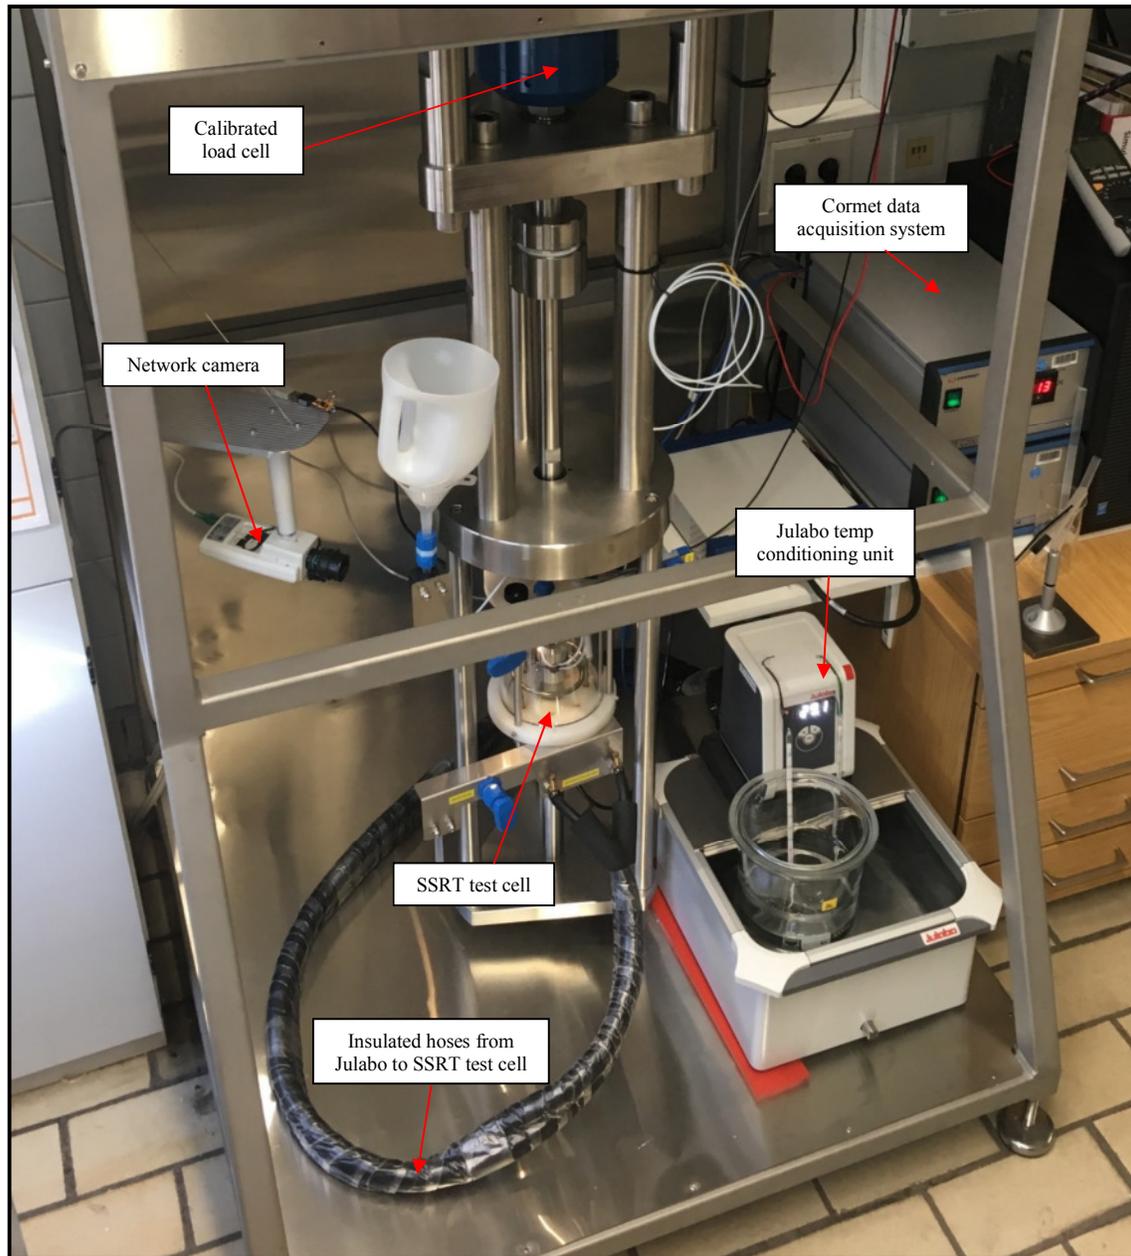
Fig 3-17: Front view of the Cormet high-precision load frame.

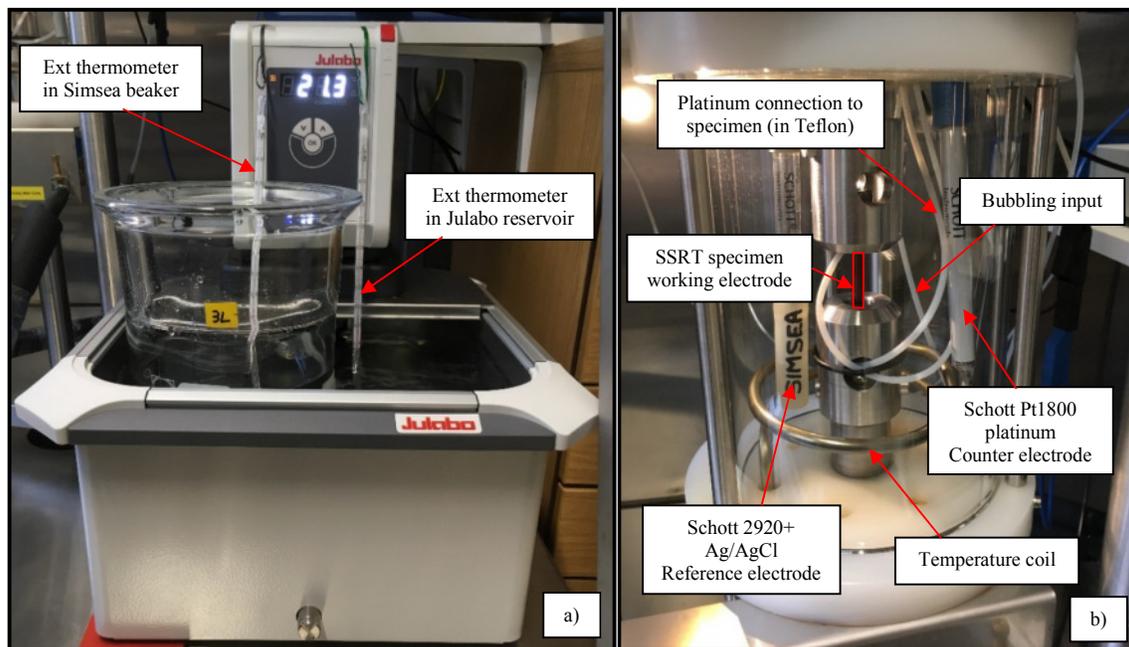
Fig 3-18: a) Julabo Corio CD temperature conditioning unit with a 4L beaker containing 2L simulated seawater being heated inside of the reservoir while the SSRT coil is also being heated, b) SSRT test cell with components identified

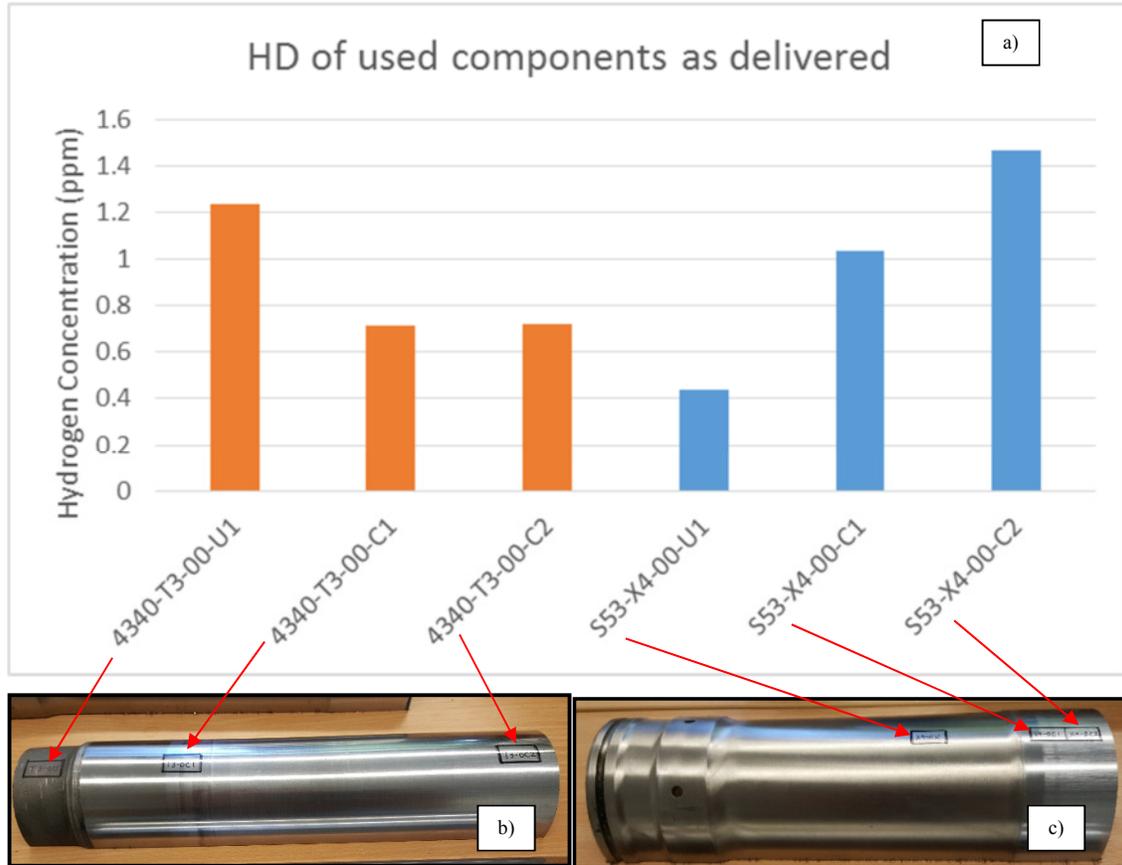
Figure 4.1: a) Hydrogen concentrations in used material, b)4340 used material extraction sites, c) S53 used material extraction sites

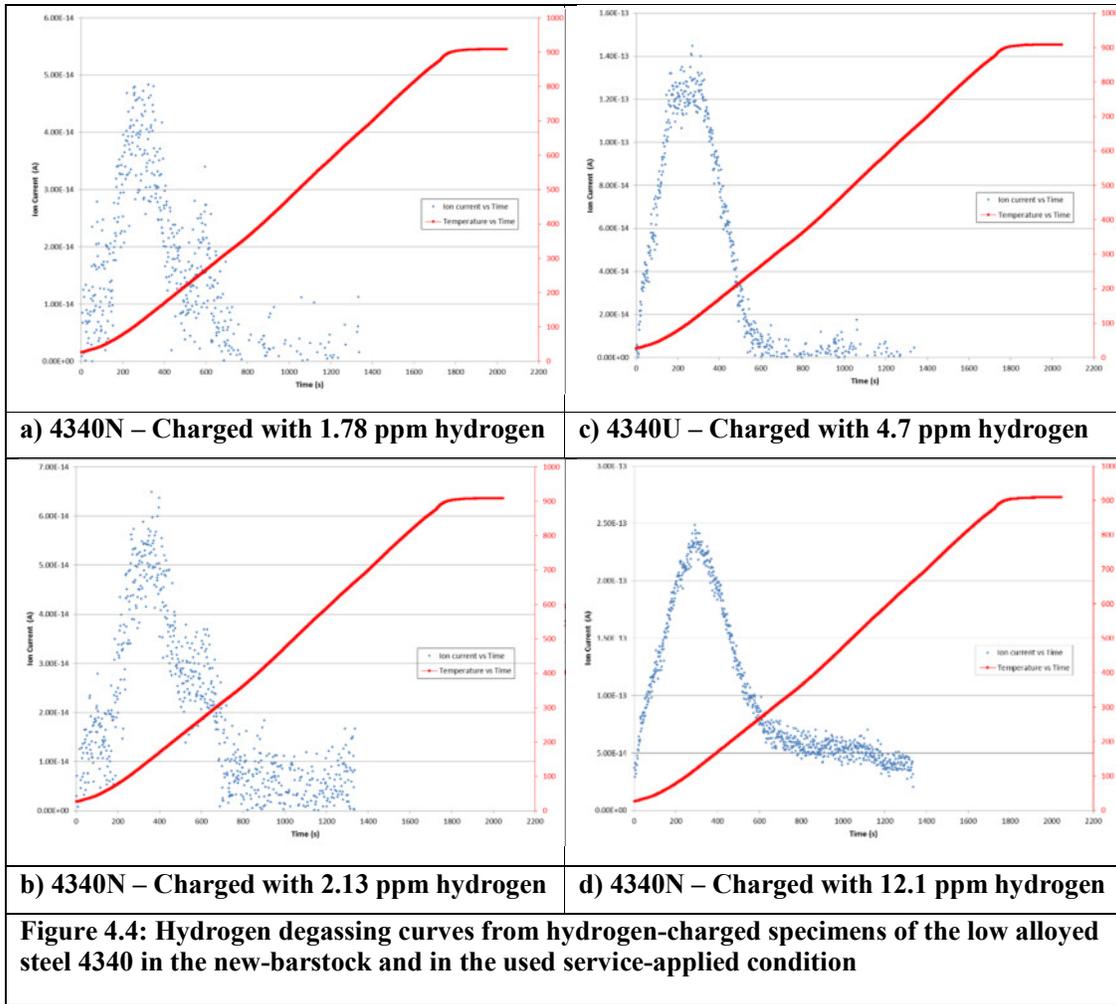
Figure 4.4 shows exemplary hydrogen degassing curves of some hydrogen-charged specimens of the steel 4340 in the new (Figures 4.4a and 4.4b) and in the used service-applied condition (Figure 4.4c and 4.4d). Although the data points show some scatter for the fairly low hydrogen concentrations dissolved in the new 4340 steel, it can be derived that particularly the new material seems to exhibit a second peak during hydrogen degassing. While the first peak corresponds to a degassing temperature of 200 °C, the second peak corresponds to about 300 °C. It can thus be anticipated that the main peak at 200 °C corresponds to the release of hydrogen from the martensitic lattice, while the second peak indicates some very slight trapping. The degassing curves, particularly at such scatter, do perhaps not allow a thorough thermal desorption analysis.

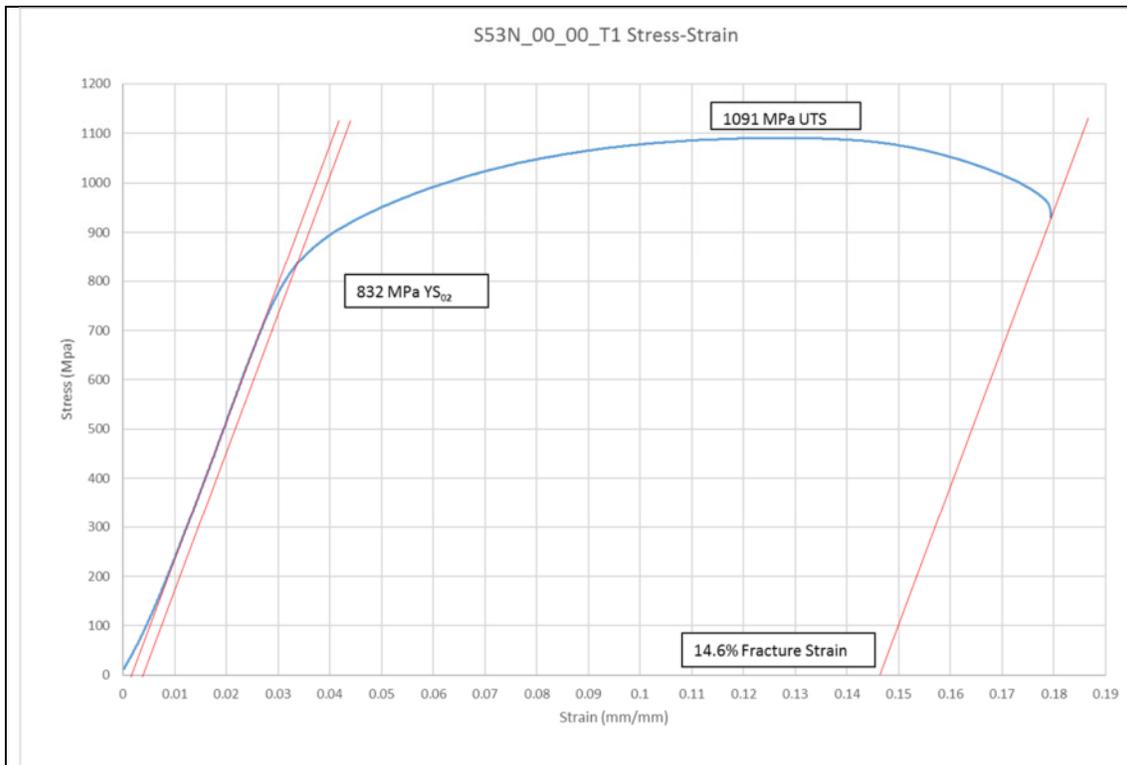
Figure 4.6: Evaluation of material properties exemplarily shown for the S53N new barstock material tensile test diagram

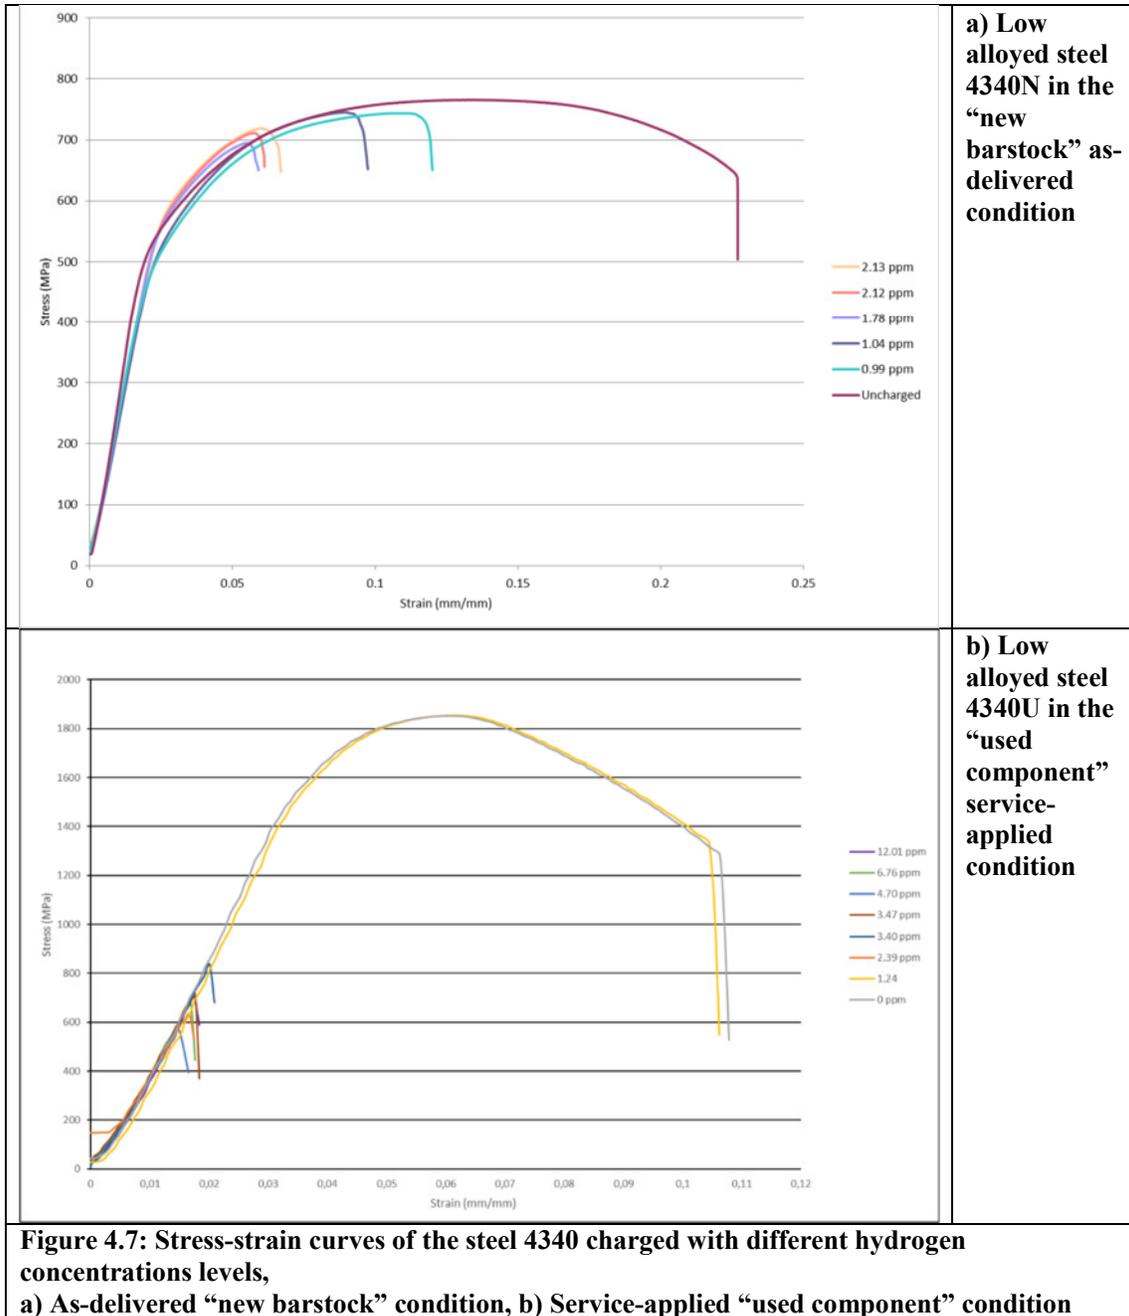
Figure 4.7: Stress-strain curves of the steel 4340 charged with different hydrogen concentrations levels, a) As-delivered “new barstock” condition, b) Service-applied “used component” condition

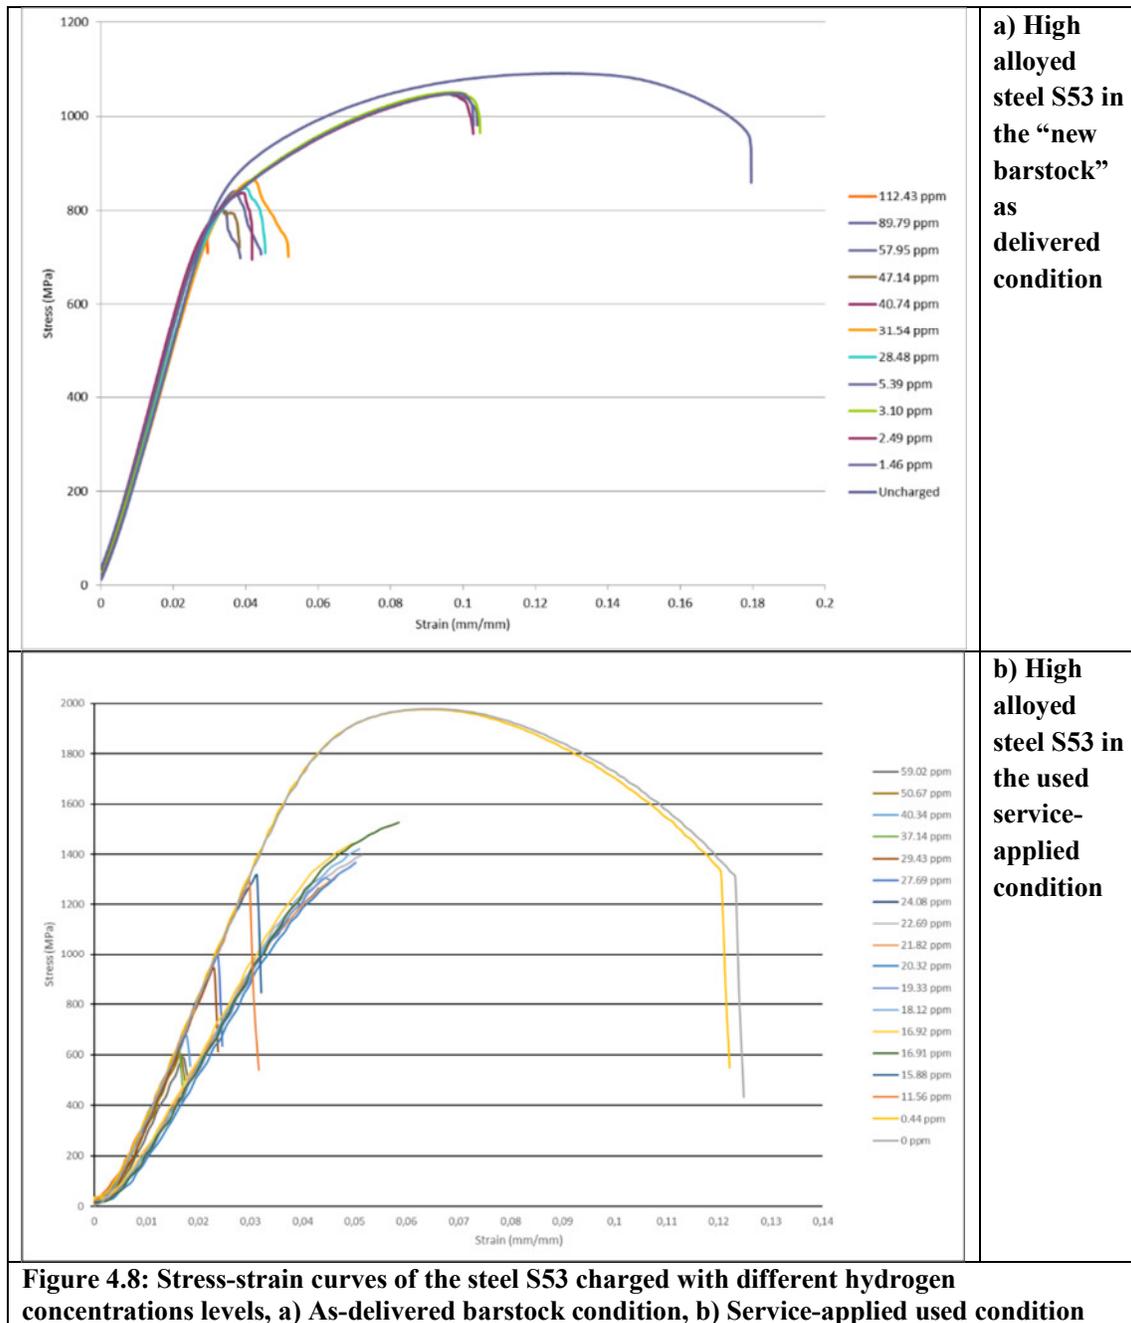
In comparison to the low alloyed steel 4340, Figure 4.8 shows the stress-strain curves for the steel S53 charged with hydrogen at various concentration levels. A comparison of the two charts shows quite clearly that also the service-applied steel S53U has a much higher strength than the

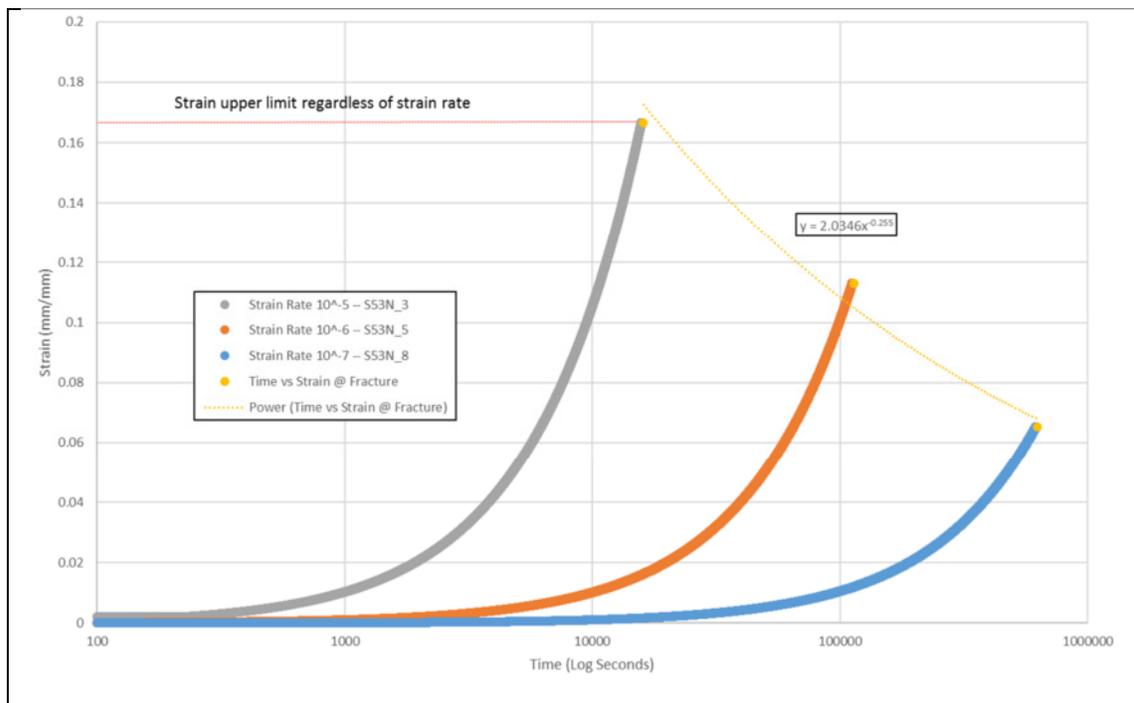
Figure 4.21: TSF diagram for the steel S53N in the as-delivered and commercially available bar-stock condition

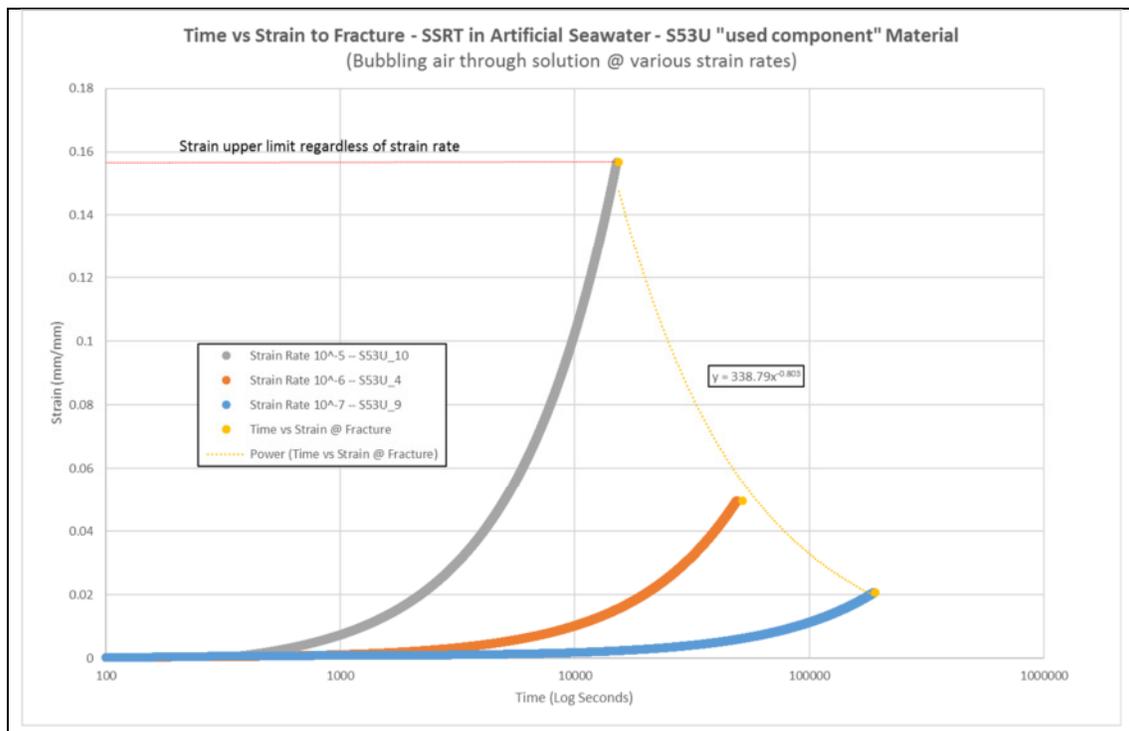
Figure 4.30: TSF diagram for the S53U steel in the service-applied “used component” condition in artificial seawater at various strain rates

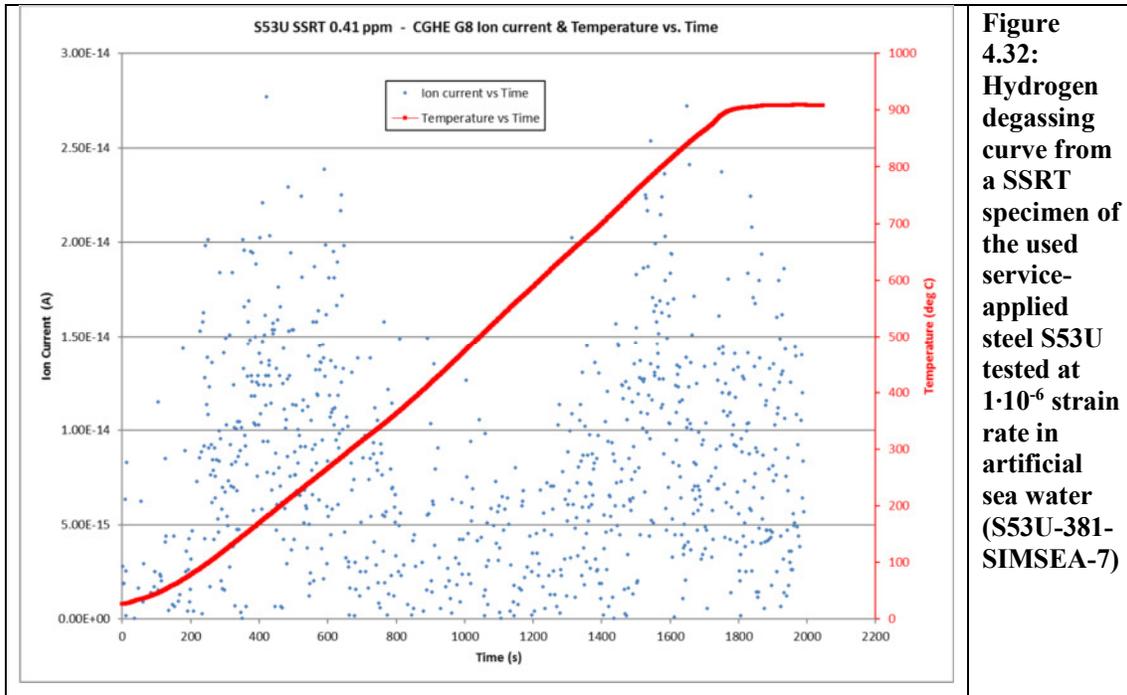
Figure 4.32: Hydrogen degassing curve from a SSRT specimen of the used service-applied steel S53U tested at $1 \cdot 10^{-6}$ strain rate in artificial sea water (S53U-381-SIMSEA-7)

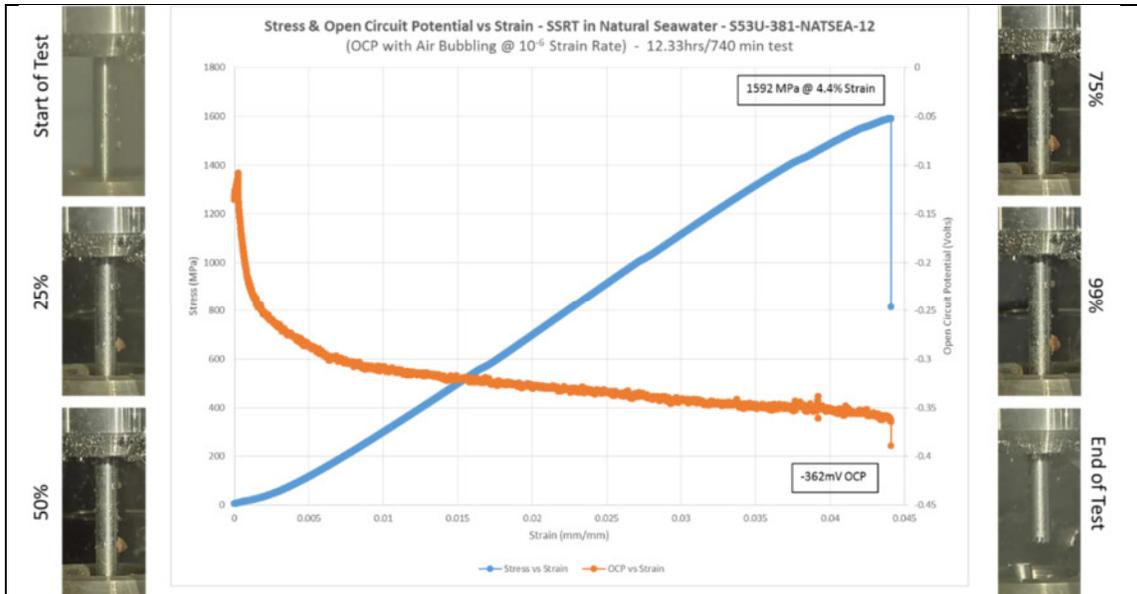
a) Hydrogen assisted stress corrosion cracking starting at a single pit

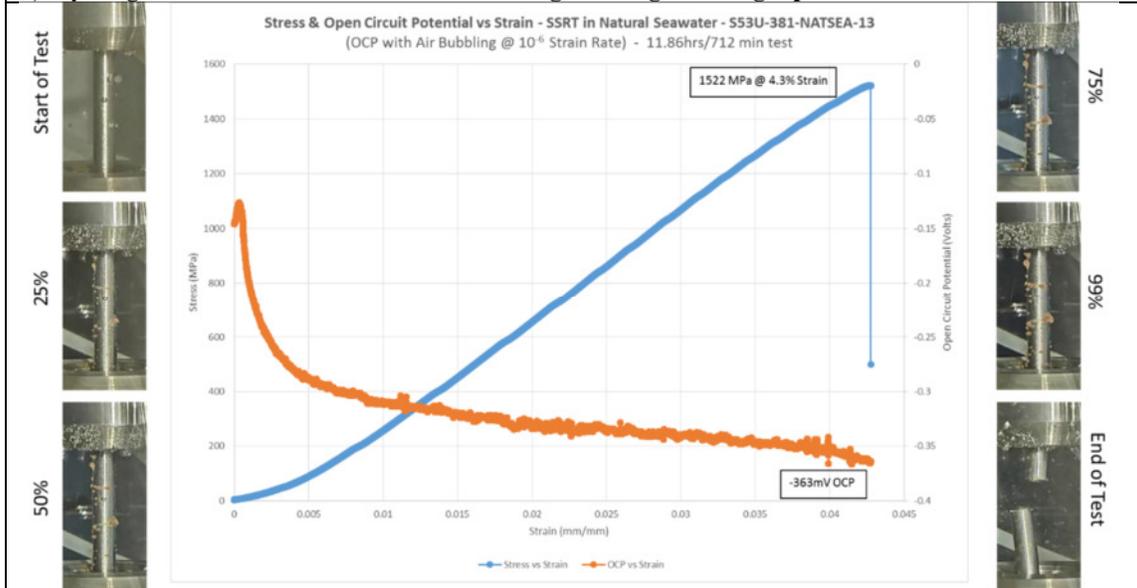
b) Hydrogen assisted stress corrosion cracking starting at numerous pits

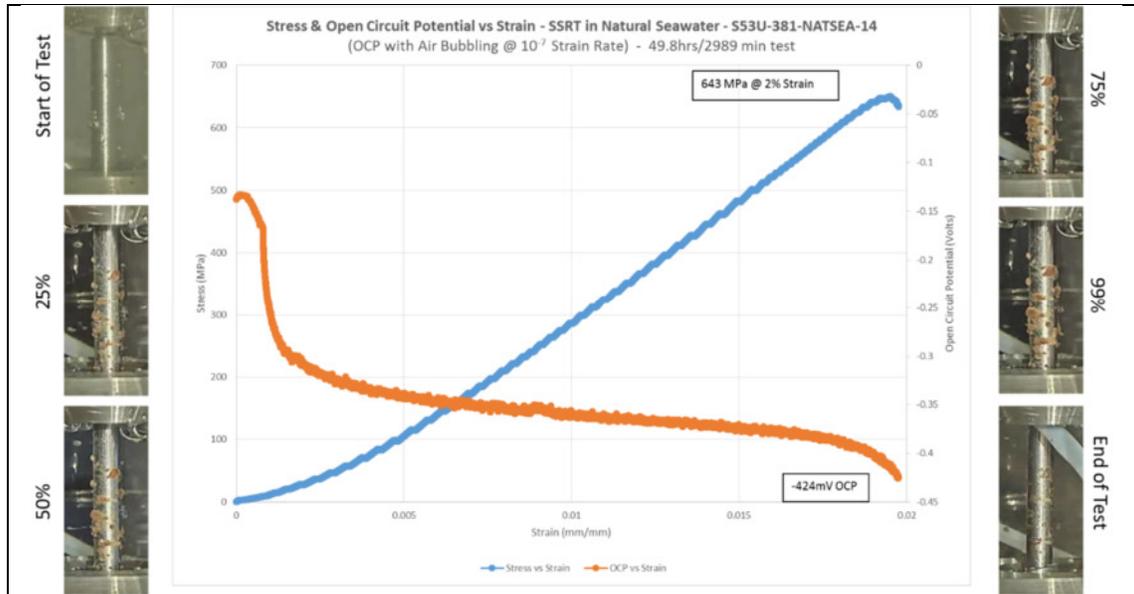
Figure 4.32: Stress-strain curve from the SSRT of the used service applied steel S53U tested at a strain rate of $\epsilon' = 1 \cdot 10^{-7}$ in natural seawater

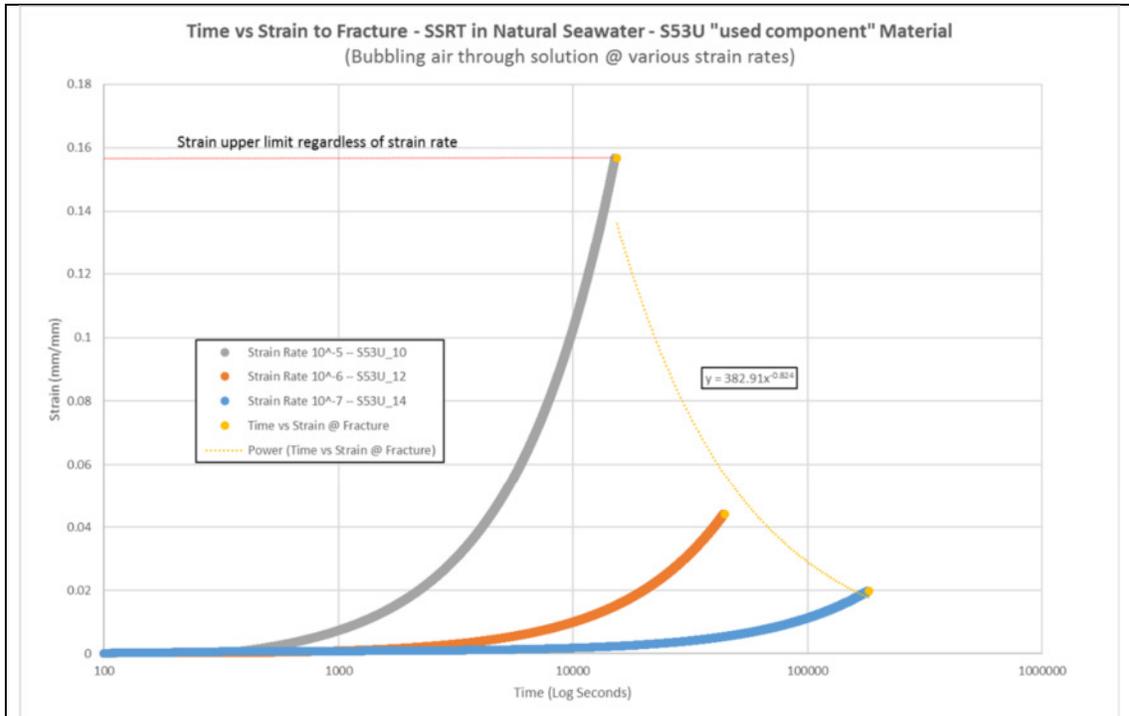
Figure 4.33: TSF diagram for the S53U steel in the service-applied “used component” condition in artificial seawater at various strain rates
