HYDROGEN ASSISTED CRACKING OF UHSS
FOR MILITARY AEROSPACE APPLICATIONS

DISSERTATION

Benjamin R. Steffens, Maj, USAF
aus Torrejon Air Force Base, Spanien

Hamburg, 2018

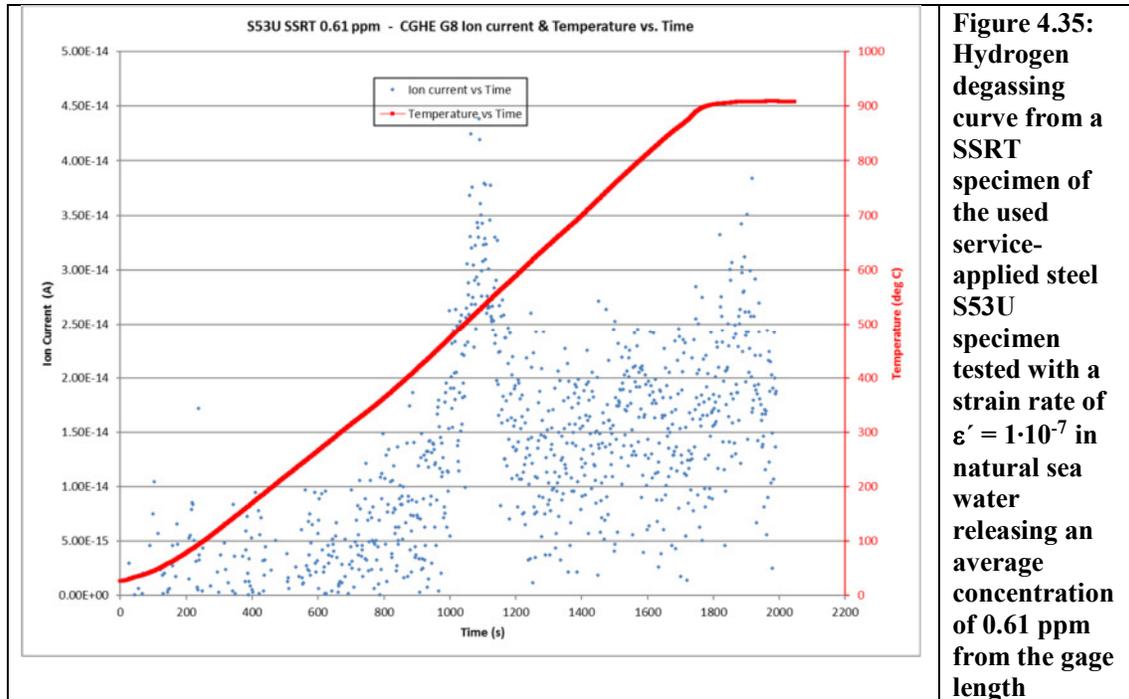
Figure 4.35:
Hydrogen
degassing
curve from a
SSRT
specimen of
the used
service-
applied steel
S53U
specimen
tested with a
strain rate of
 $\epsilon' = 1 \cdot 10^{-7}$
in
natural sea
water
releasing an
average
concentration
of 0.61 ppm
from the gage
length

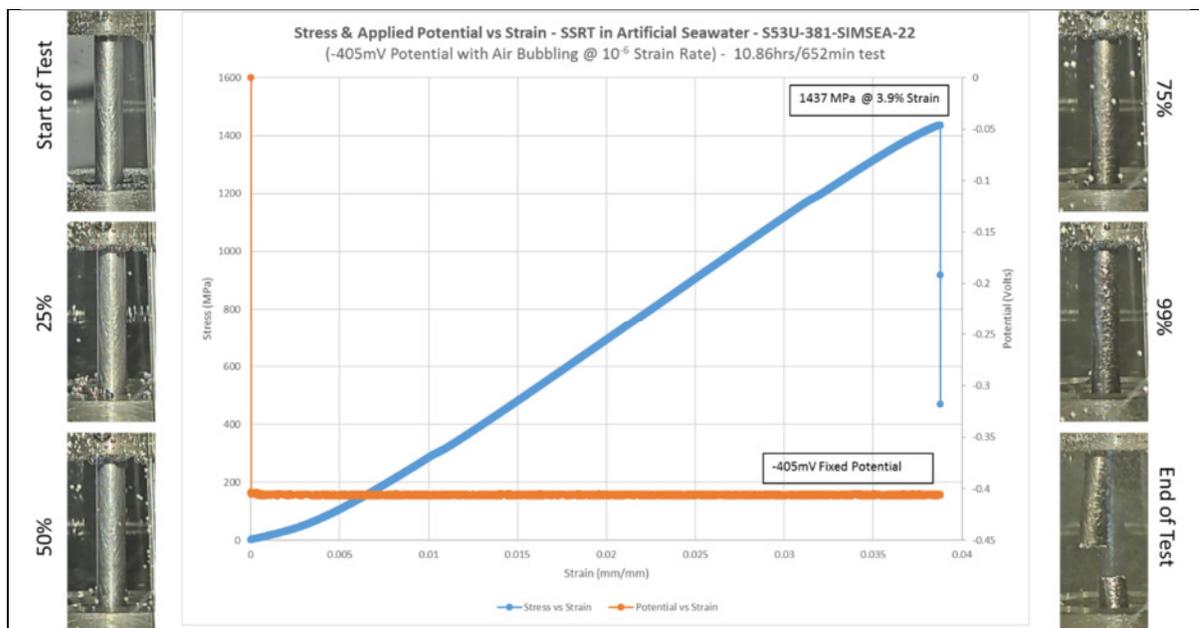
Figure 4.36: Stress-strain curve from the SSRT of the used service applied steel S53U tested at a strain rate of $\epsilon' = 1 \cdot 10^{-6}$ in artificial seawater at a fixed electrochemical potential of -405 mV (Ag/AgCl)

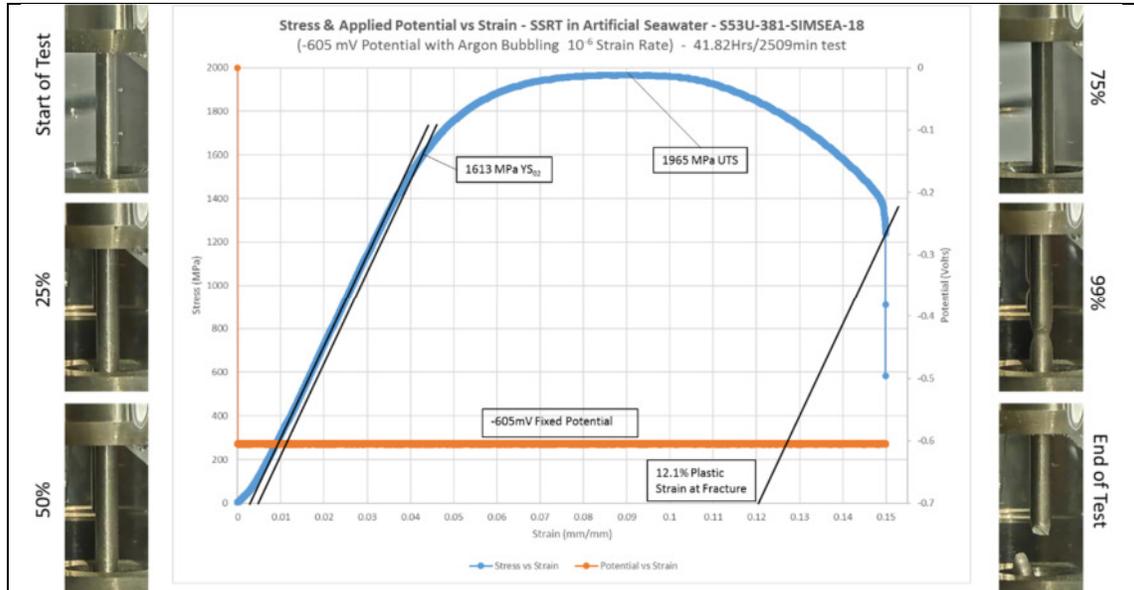
a) Ductile fracture in the lower half of the specimen

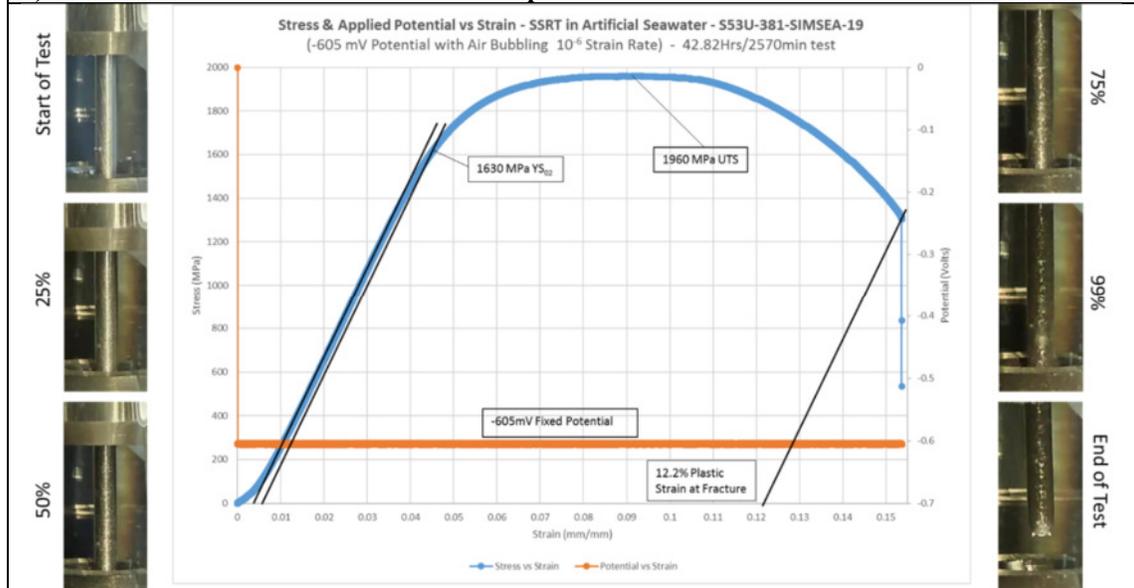
b) Ductile fracture in the lower half of the specimen

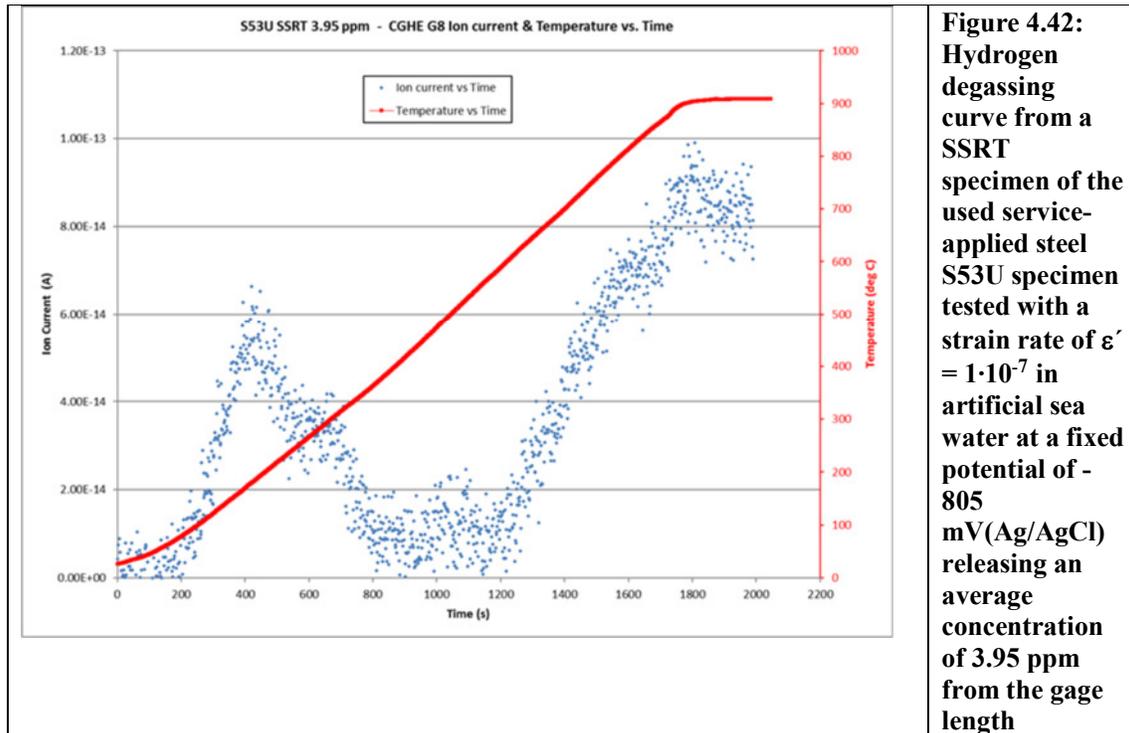
Figure 4.42: Hydrogen degassing curve from a SSRT specimen of the used service-applied steel S53U specimen tested with a strain rate of $\epsilon' = 1 \cdot 10^{-7}$ in artificial sea water at a fixed potential of -805 mV(Ag/AgCl) releasing an average concentration of 3.95 ppm from the gage length

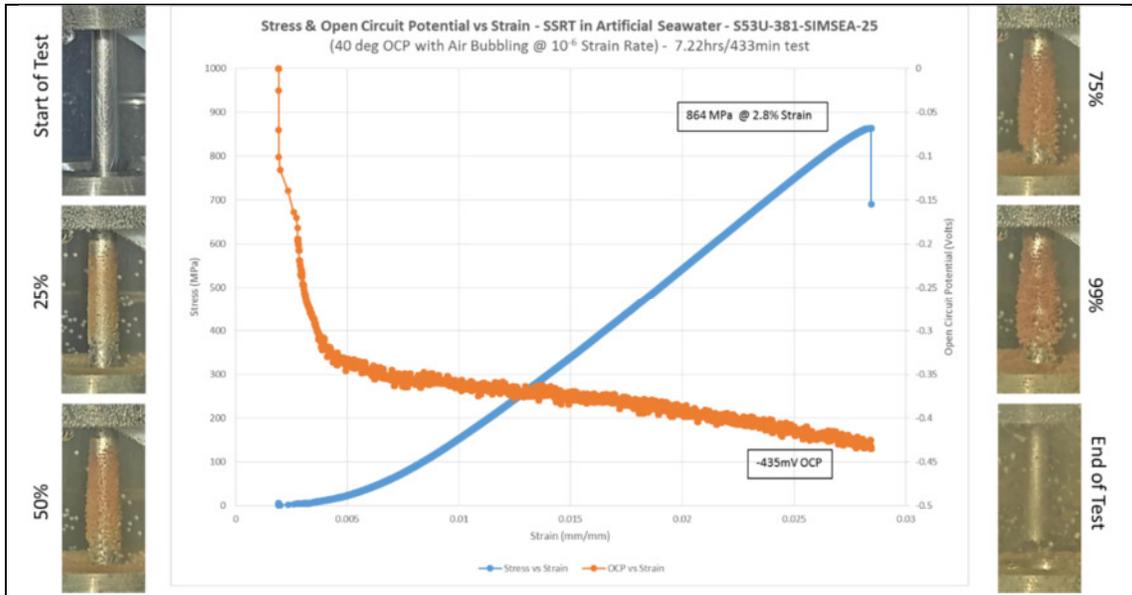
Figure 4.43: Stress-strain curve from the SSRT of the used service applied steel S53U tested at a strain rate of $\dot{\epsilon} = 1 \cdot 10^{-6}$ in artificial seawater at a temperature of 40 °C under OCP
